Company B4 U Buy Home & Property Inspections
Address 15466 91A Ave, Surrey, BC, V3R 9W8
Thermographer Dan Lagerstrom

Customer John & Jane Doe
Site Address 17984 61st Ave, Cloverdale, BC
Contact Person

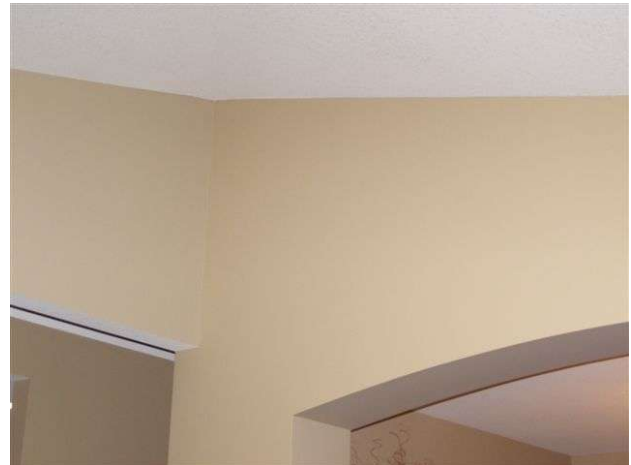
Description
Small section of missing insulation above doorway.

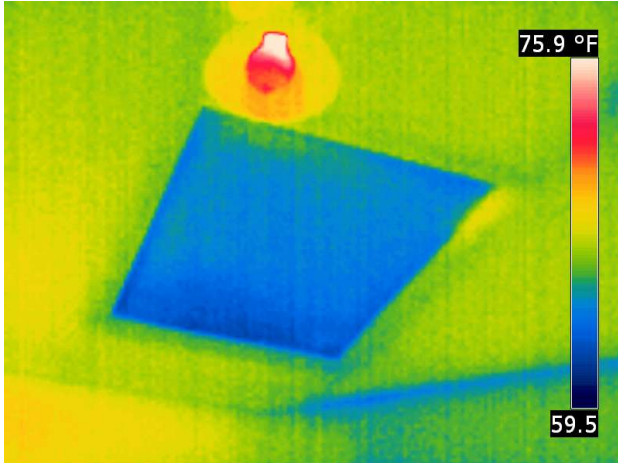
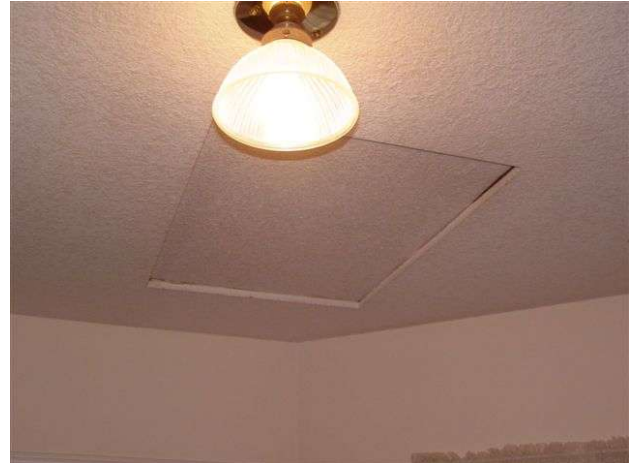
Description
Inadequate insulation on attic access hatch.
