# B4 U Buy Home and Property Inspections

## CONFIDENTIAL INSPECTION REPORT

12382 Balsam Dr, Langley, BC

11/7/2007 11:00 am to 2:30 pm

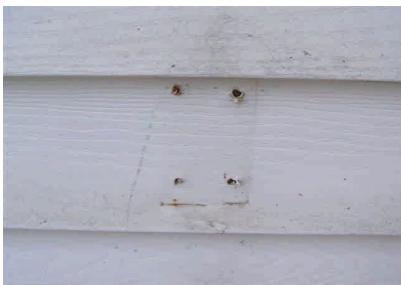
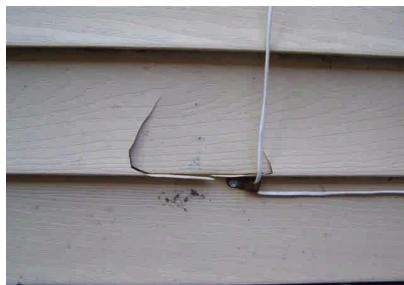
Some of the siding has impact type damage and should be repaired/monitored for leaks.

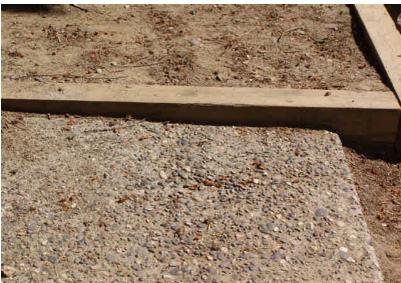
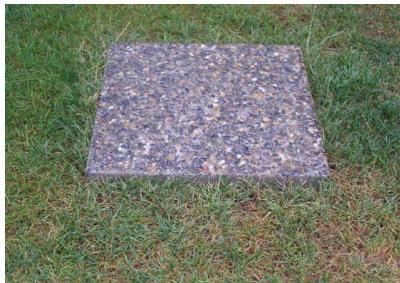
There is an offset in a walkway that could prove to be a trip-hazard.

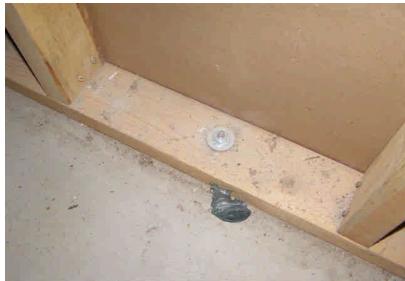
The residence has a bolted, slab foundation with no visible or significant abnormalities.

The concrete slab slopes 7/8 inches. Less than 1 inch in 20 feet is considered acceptable.

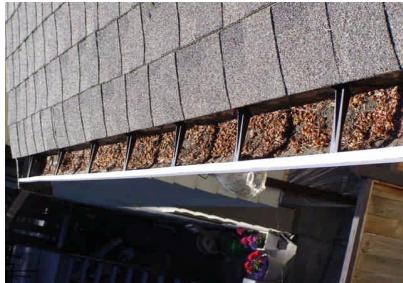
The gutters need to be serviced to drain properly.

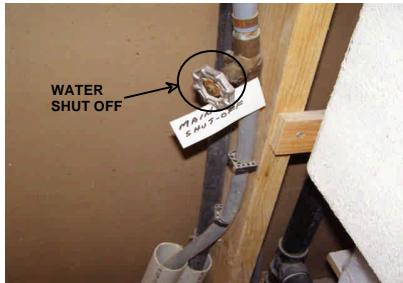
The main water shut-off valve is located adjacent to the entry.

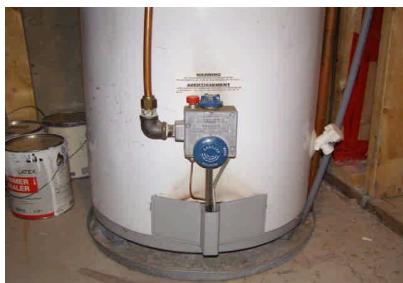
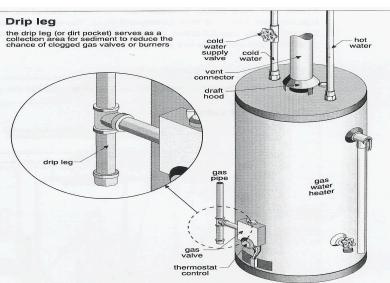
There is not a drip leg present in the gas line which can result in a clogged burner. I recommend having one installed when the water tank is replaced.

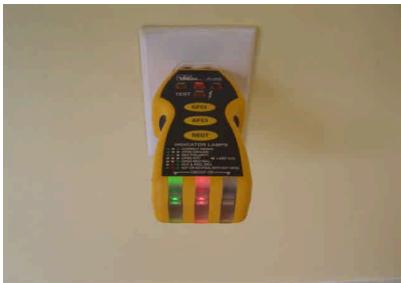
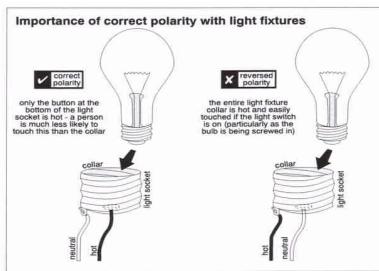
An outlet has reversed polarity, and should be serviced.

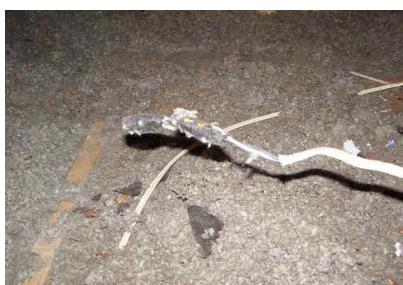
There is some abandoned wiring left in the attic which should be removed back to a box or panel, or terminated in a junction box. This wire is currently live.

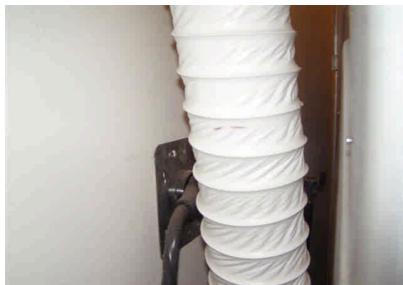
The dryer vent is a flexible plastic type that traps lint more easily than a smooth metal type, which can compromise the performance of the dryer and can facilitate a fire, and you may wish to consider replacing it.

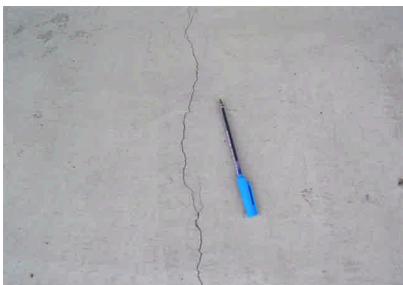
There are some hollow areas under the slab, which may crack at some time in the future. This is caused by incomplete excavation when the dwelling was constructed.

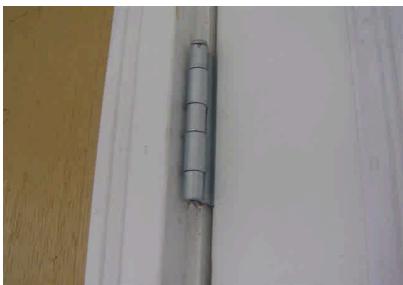
The door swings outward, and poses a security risk, as entry could be gained by simply removing the hinge pins. These should be replaced with Non-removable pin (NRP) type.
